# Manhole Inspection Summary

Manhole # S35WW\_014MH

Insp Date: **1/9/07 8:54 AM**

**Location** Address: **307 30TH ST**

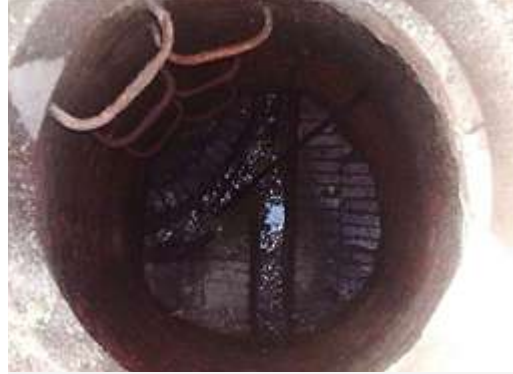
Top View

Corroded steps. Evidence of surcharge - Bench debris. Channel debris.

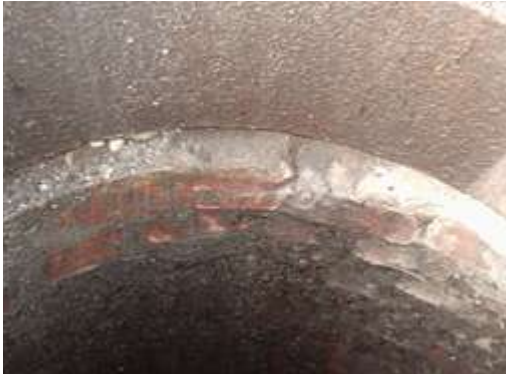
Defect

Frame leaks. Adjustment deterioration and infiltration.

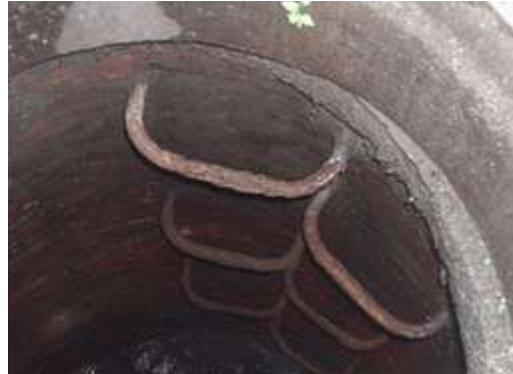
Defect

Frame leaks. Adjustment infiltration.

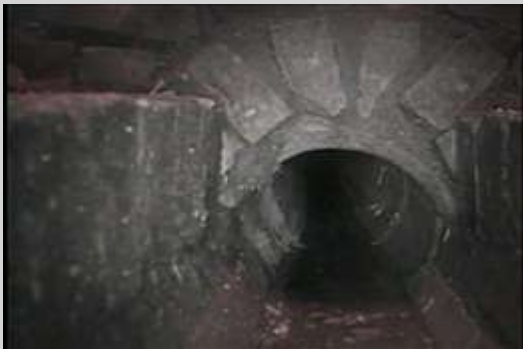
### 8 in. Circular Gravity Sewer Pipe In @ 6 O'Clock

Infiltration: **None** Pipe Seal Cond: **Roots**
